VEHICLE INSPECTION REPORT

SL23HPE

DAF CF 450

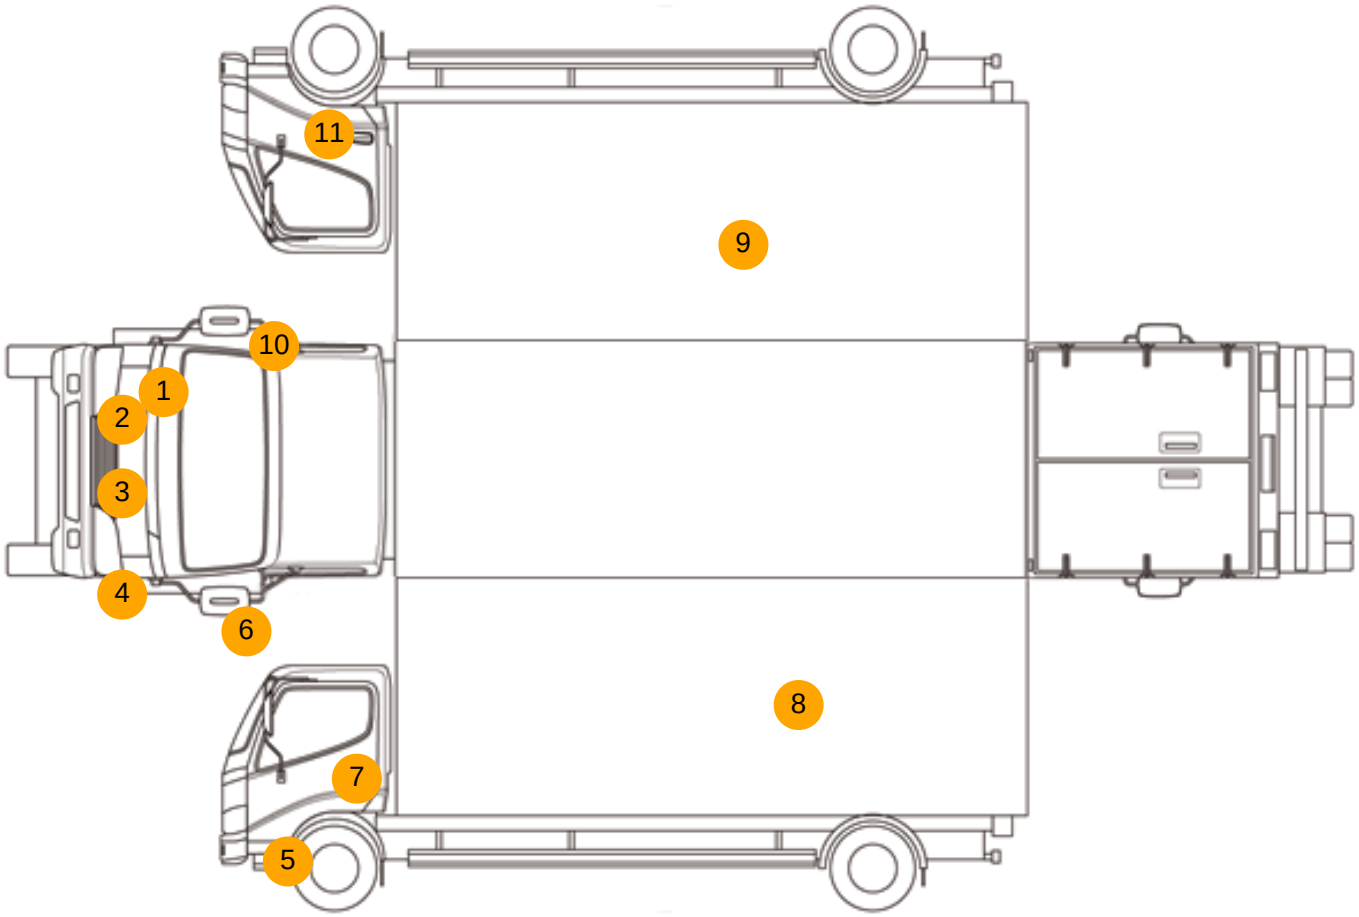
Condition Check

1: Wing osf
Chipped
1 To 5

2: Bumper Front
Scratched
25 to 100mm Thru Paint

3: Bumper Front
Scratched
25 to 100mm Thru Paint

4: Bumper Front
Scratched
Over 100mm Thru Paint

5: Wing Front Arch Extension ns
Scratched (Painted)
Over 25mm Thru Paint

6: Door Mirror Assy nsf
Scuffed (Unpainted)
Over 100mm

7: Door nsf
Scratched
Over 25mm Not Thru Paint

8: Qtr Panel nsr
Dented
With Paint Damage

9: Qtr Panel osr
Dented
With Paint Damage

10: Door Mirror Assy osf
Scuffed (Unpainted)
Over 100mm

11: Wing Front Arch Extension os
Scuffed (Unpainted)
Over 100mm
